Presonus Eris E3.5 (Gen 1) - Non BT - Electrolytic Capacitor List

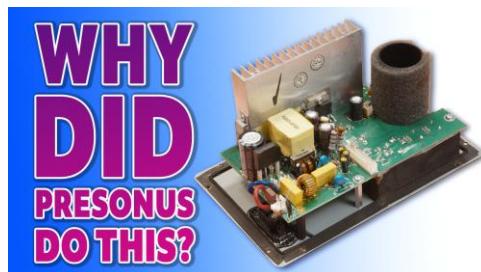
Location	Temp	ESR	uF	Voltage	Approx Radius	Notes
C13	105 Deg	STD ESR	10	50	5.3mm	Replaced Rubycon 10k hours at 105 Deg
C17	105 Deg	Low ESR	1000	25	10.2mm	Replaced Panasonic FR Series Ultra Low ESR 10k hours at 105 Deg
C18	105 Deg	Low ESR	1000	25	10.2mm	Replaced Panasonic FR Series Ultra Low ESR 10k hours at 105 Deg
C19	105 Deg	STD ESR	470	25	8.2mm	Replaced Panasonic FR Series Ultra Low ESR 9k hours at 105 Deg 35v
C22	105 Deg	STD ESR	470	25	8.2mm	Replaced Panasonic FR Series Ultra Low ESR 9k hours at 105 Deg 35v
C12	105 Deg	STD ESR	100	400	18.2mm	Bought Japanese United ChemiCon cap from ebay
C70	105 Deg	STD ESR	4.7	100	10.2mm	NON POLAR - Had to settle for the premium house brand Multicomp Pro.
C80	105 Deg	STD ESR	10	16	5.2mm	Upgraded to Panasonic 50v parts that will fit.
C81	105 Deg	STD ESR	10	16	5.2mm	Upgraded to Panasonic 50v parts that will fit.
C74	105 Deg	STD ESR	47	25	5.2mm	Upgraded to Panasonic 50v parts that will fit.
